# NAVAL POSTGRADUATE SCHOOL

# THESIS

**STRESS RELIEF CRACKING IN  
COPPER-PRECIPITATION STRENGTHENED  
HSLA-100 STEEL**

Steven A. McNutt

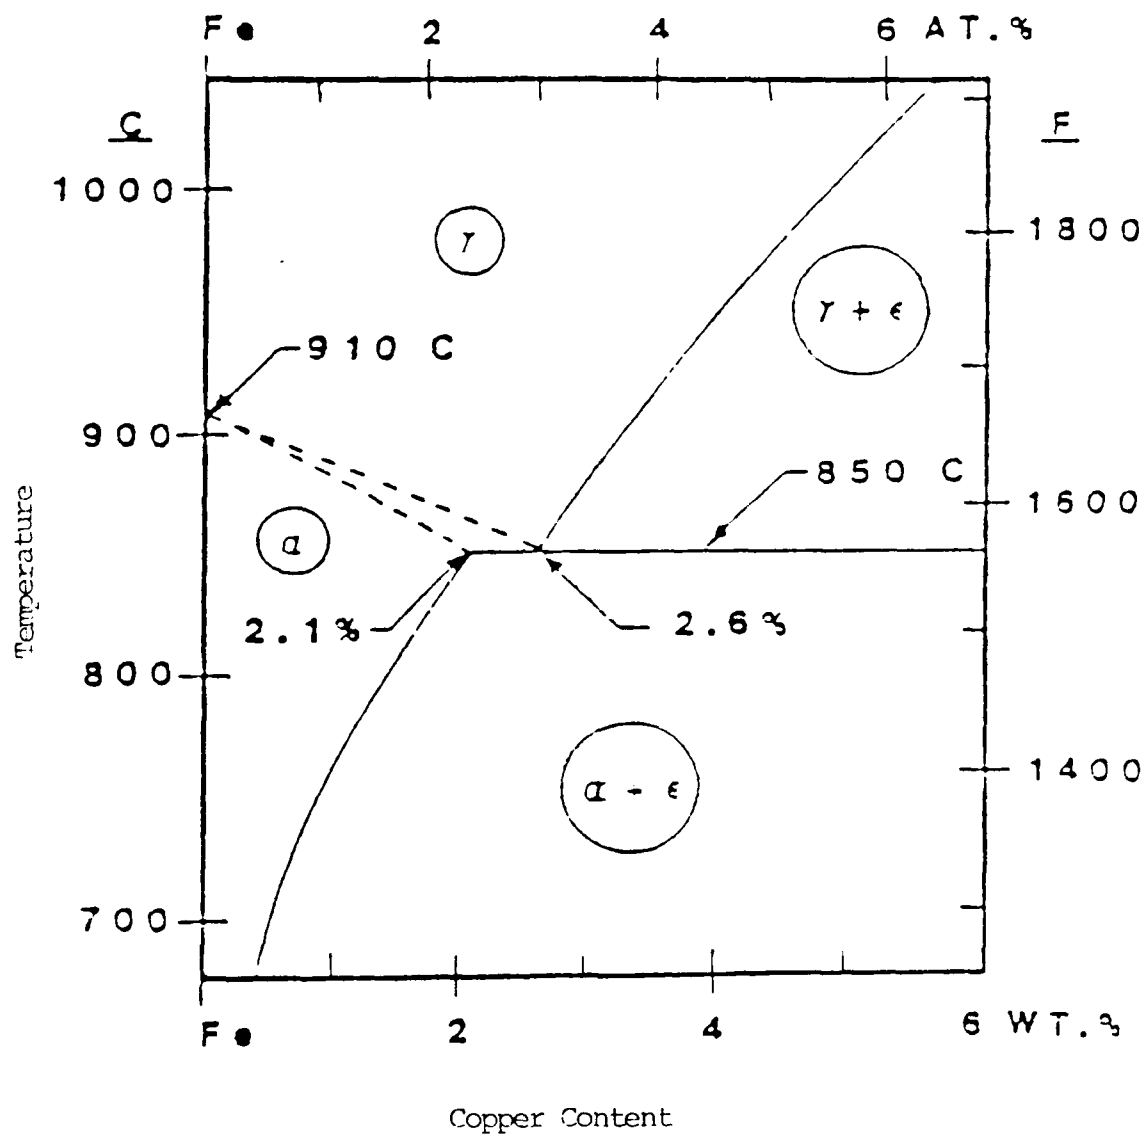
Figure 1. Iron Rich Portion of the Fe-Cu Phase Diagram [Ref. 15]

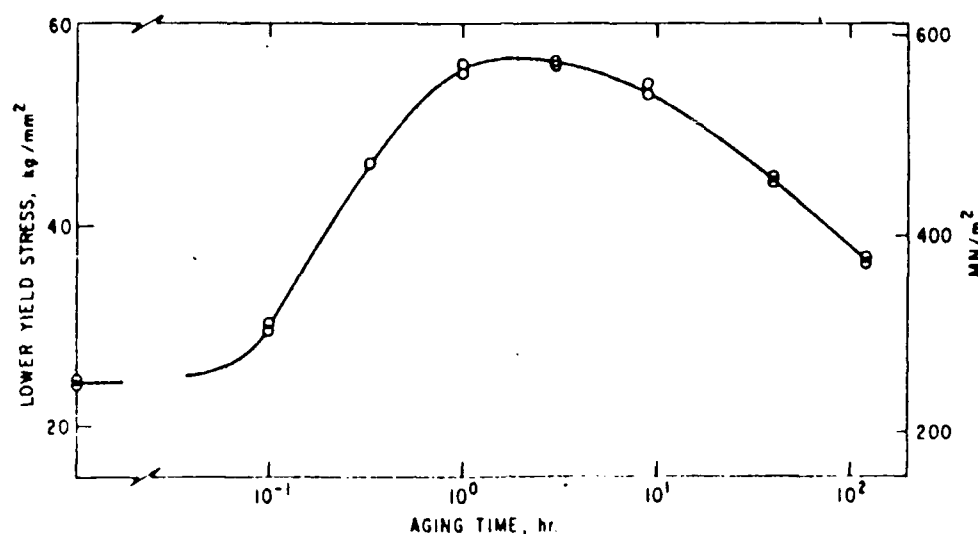
Figure 2. **Yield Stress of Fe-1.4 percent Cu as a Function of Aging Time at 500° C [Ref. 21]**

The grain size observed in HSLA-100 copper-precipitation strengthened steel is relatively fine and can be considered the main microstructural feature. The strengthening is realized from a combination of the bainitic microstructure, dislocation density, copper precipitation, and solid solution strengthening. The competing reactions of these strengthening mechanisms make this fine-grain-sized matrix insensitive to the variation of heat treatment. Recovery (lowering the strength) takes place by the rearrangement and annihilation of dislocations, while the precipitation of copper increases the strength. The mechanical behaviour of the alloy is determined by the size and volume fraction of copper-rich precipitates which are the most sensitive to temperature. This is a direct result of the gradual decrease of the hardness profile after aging the alloy to its maximum strength. The length of time the material retains this hardness is a function of temperature and time, but the time can be of considerable length, as seen in Figure 2. [Refs. 22, 23]

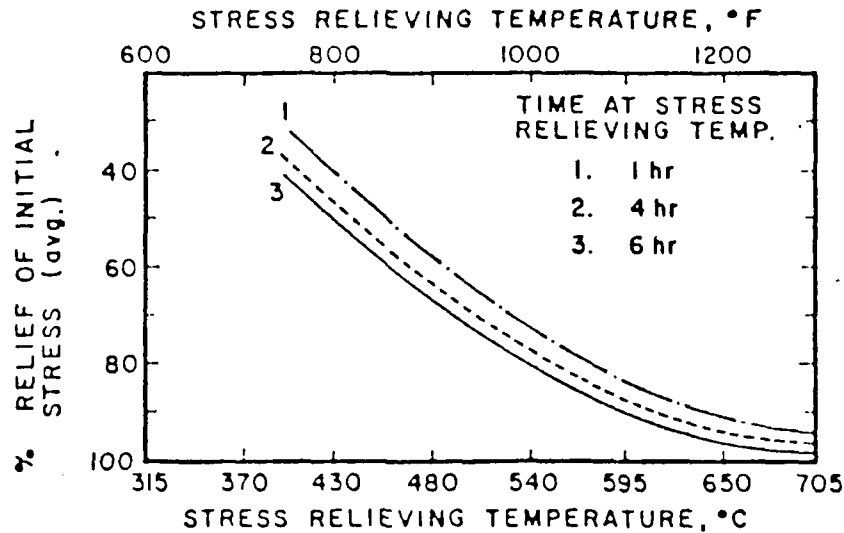
Figure 3. **Stress Relief in a Carbon Steel** [Ref. 26]

steel to sustain the residual stress level causes the initiation of plastic deformation to relax the stresses. Additional relaxation can occur by creep action if heating is continued. Figure 3 illustrates the amount of stress relaxation as a function of time and temperature. A Larson-Miller parameter,  $P$ , has been developed to describe the relaxation of residual stress by creep as a function of time and temperature. It is given as

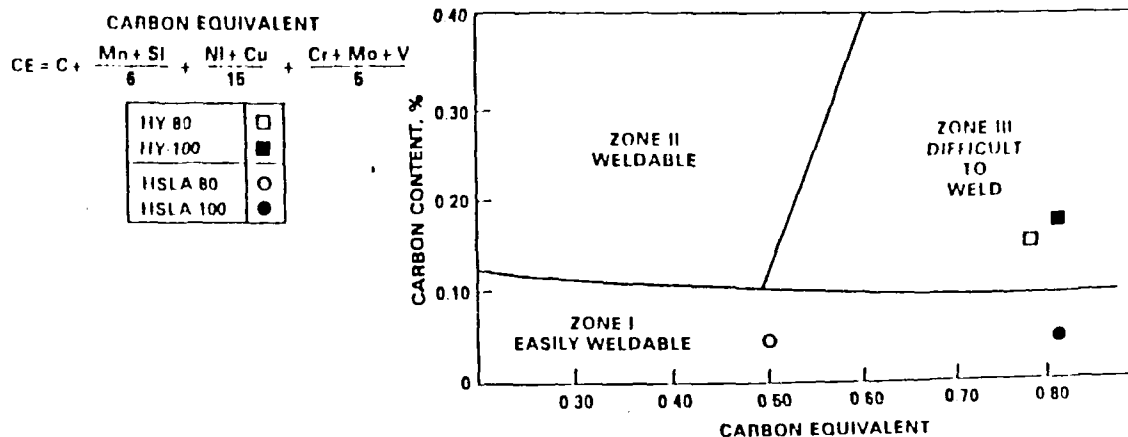
Figure 4. Granville Diagram—Chemical Composition, Carbon Equivalents, and Weldability for HY-80, HY-100, HSLA-80, and HSLA-100 Steels

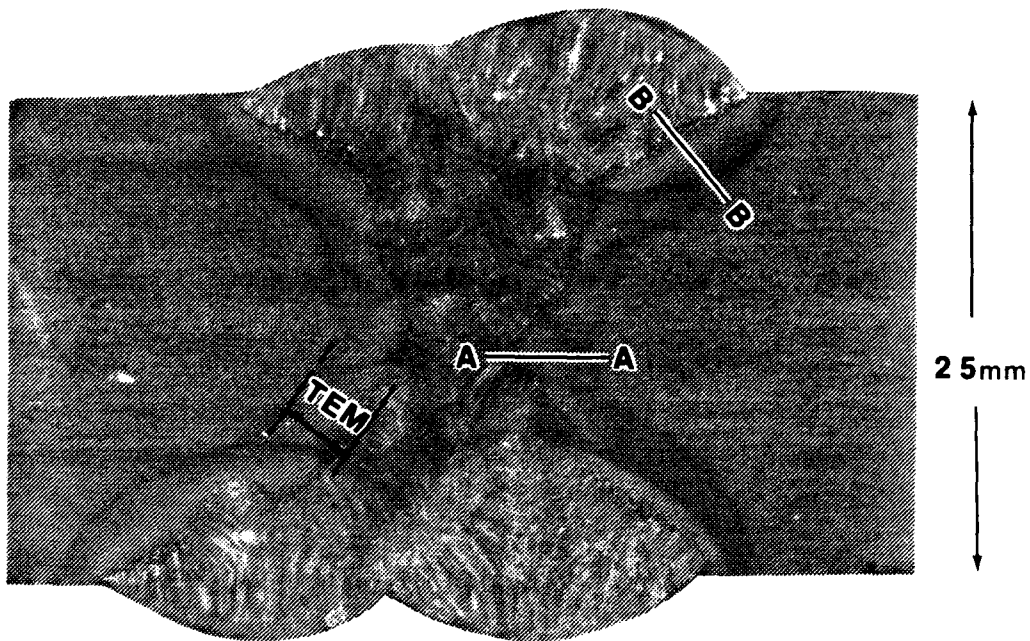
Figure 6. **Macrostructure of the Weld Passes and HAZ**

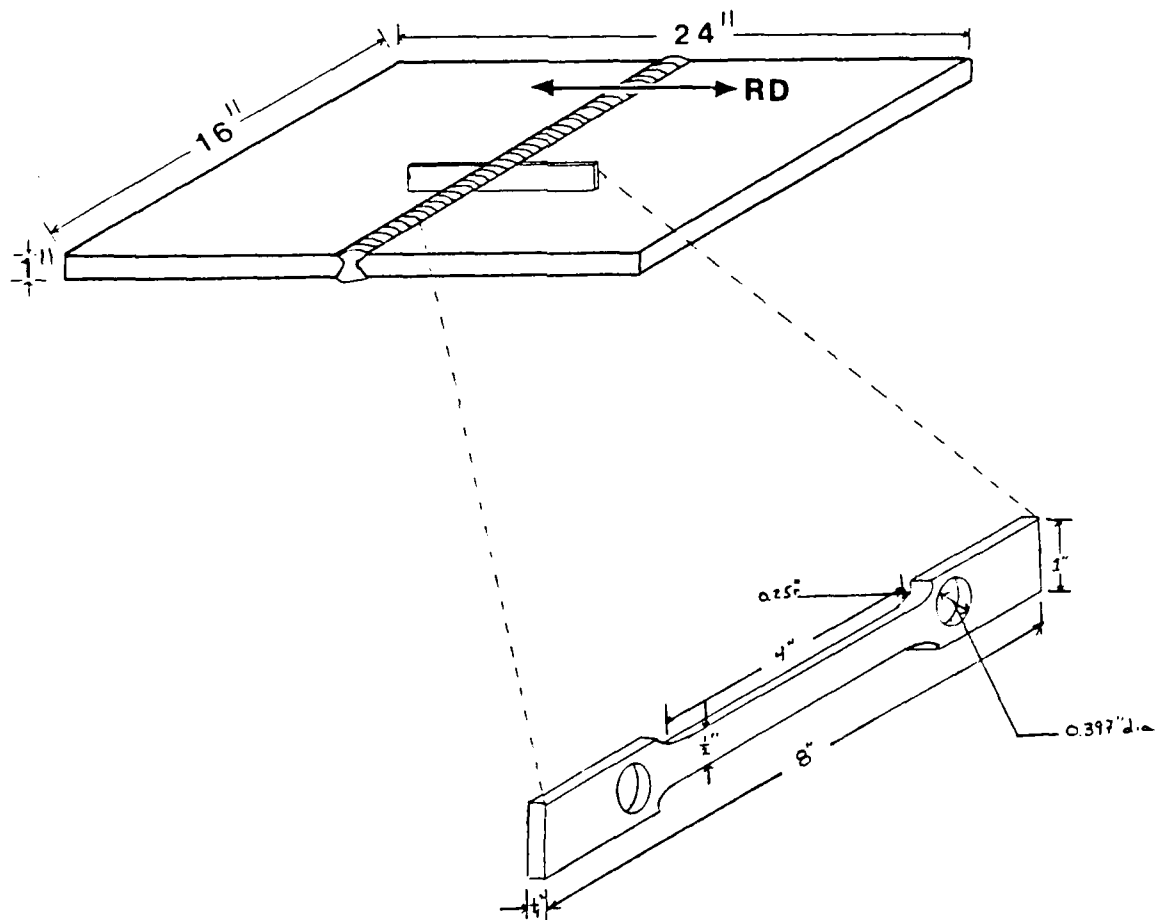
Figure 7. Plate and Tensile Specimen Dimensions

The remainder of the plate was sectioned perpendicular to the weld direction, parallel to the first cut, to produce 6 mm thick slices for cutting flat tensile specimens. The weld was located in the center of the gauge length, as illustrated in Figure 7. The tensile specimens

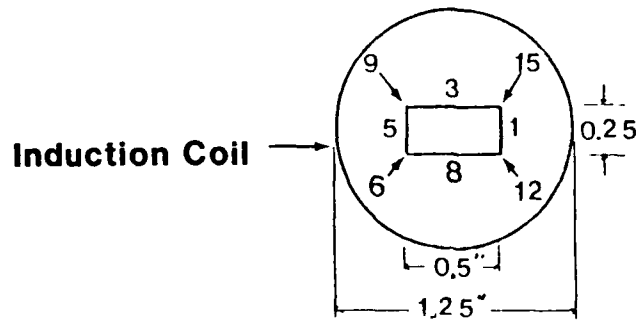
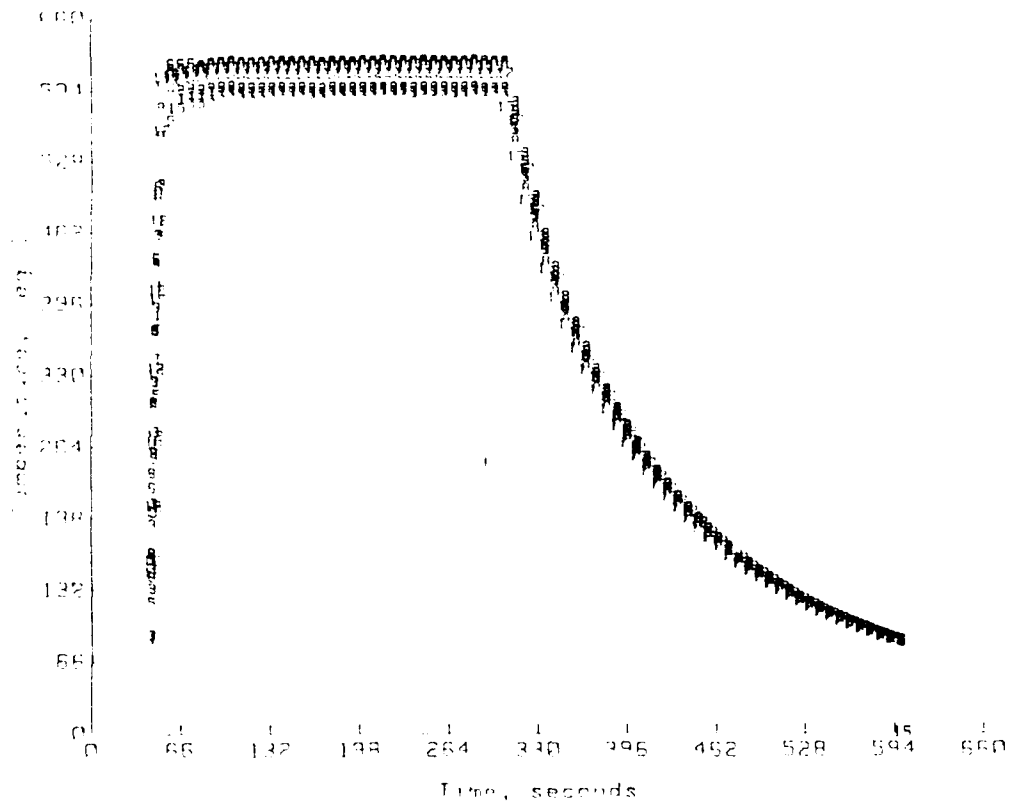
Thermocouple Placement on the Test Specimen in the Induction Coil

Note the small temperature gradient maintained throughout the test.

Figure 8A. Temperature Changes With Time in Several Locations Around a Cross-Section of the Specimen

Temperature profiles for this circular coil, with time, are shown in Figure 8. Figure 8A shows the temperature changes with time in

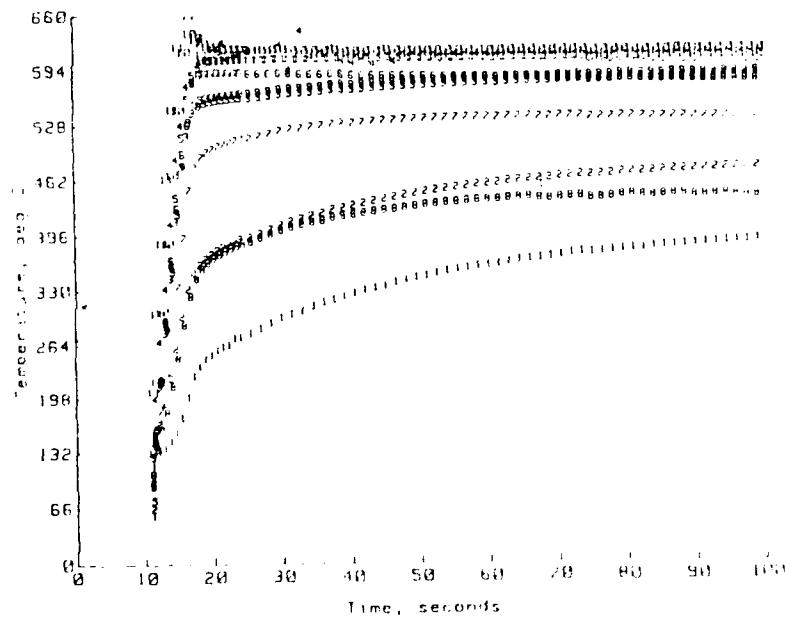
Thermocouple Placement on the Specimen in the Induction Coil

Note the small temperature gradient in the center of the gauge length.

Figure 8B. **Temperature Changes Along the Specimen**

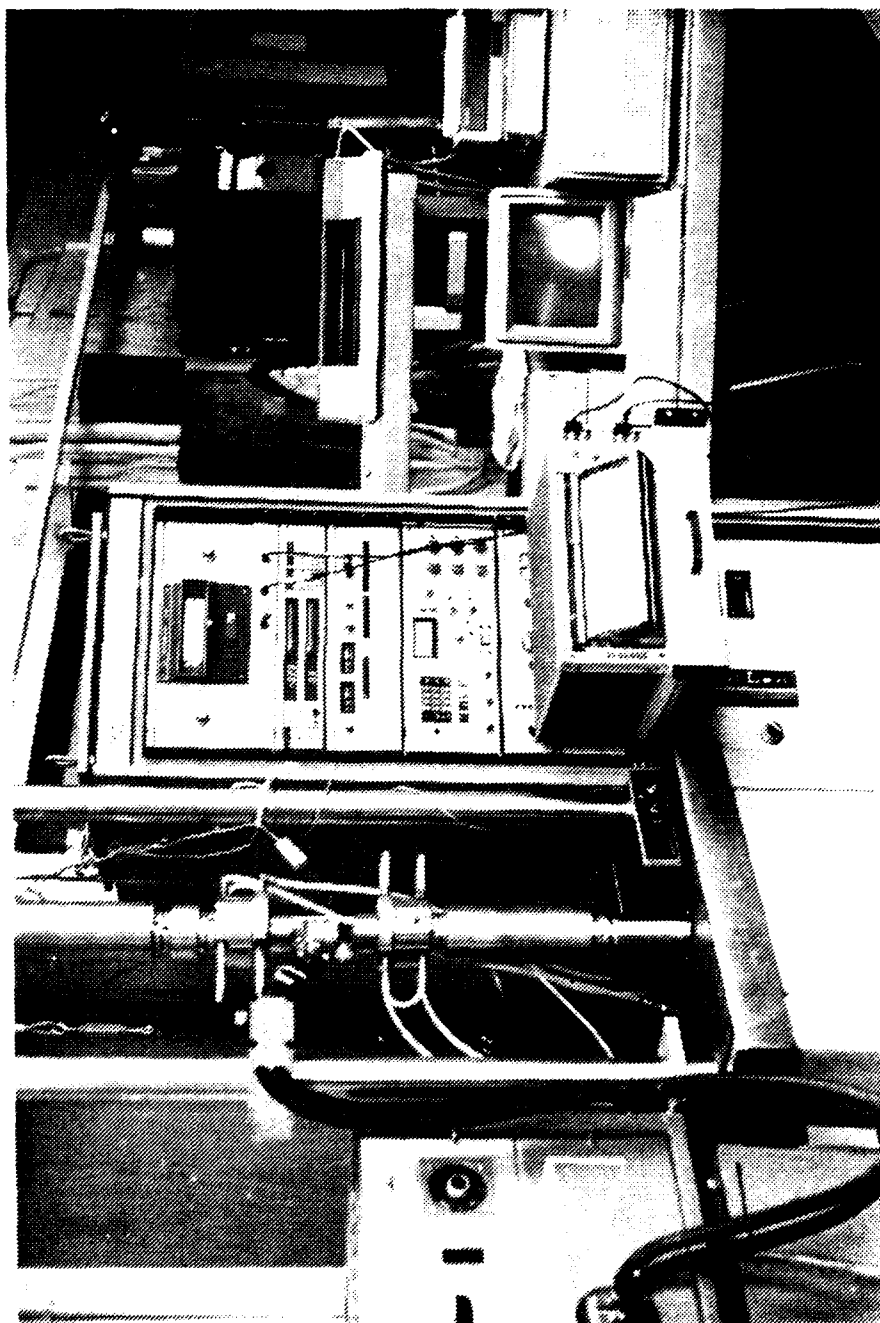
Figure 9A. Testing Apparatus

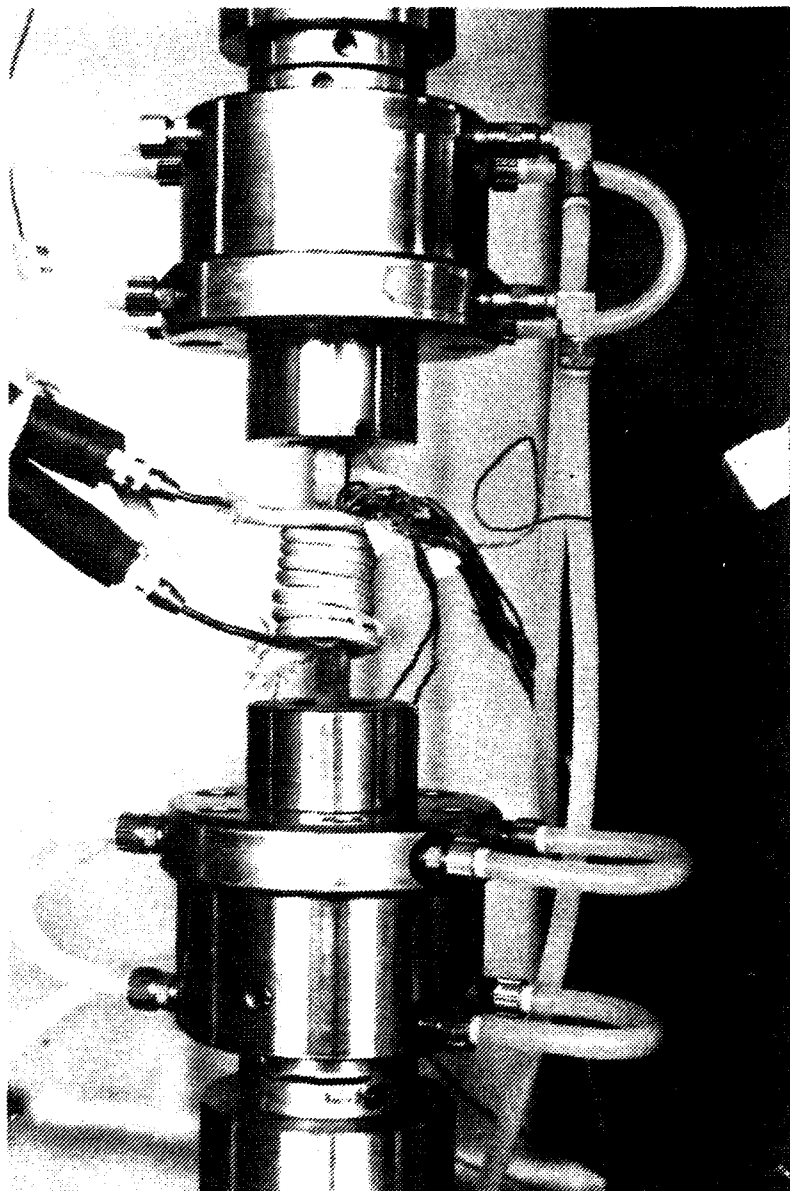
Figure 9B. **Testing Apparatus—Grip Assembly**

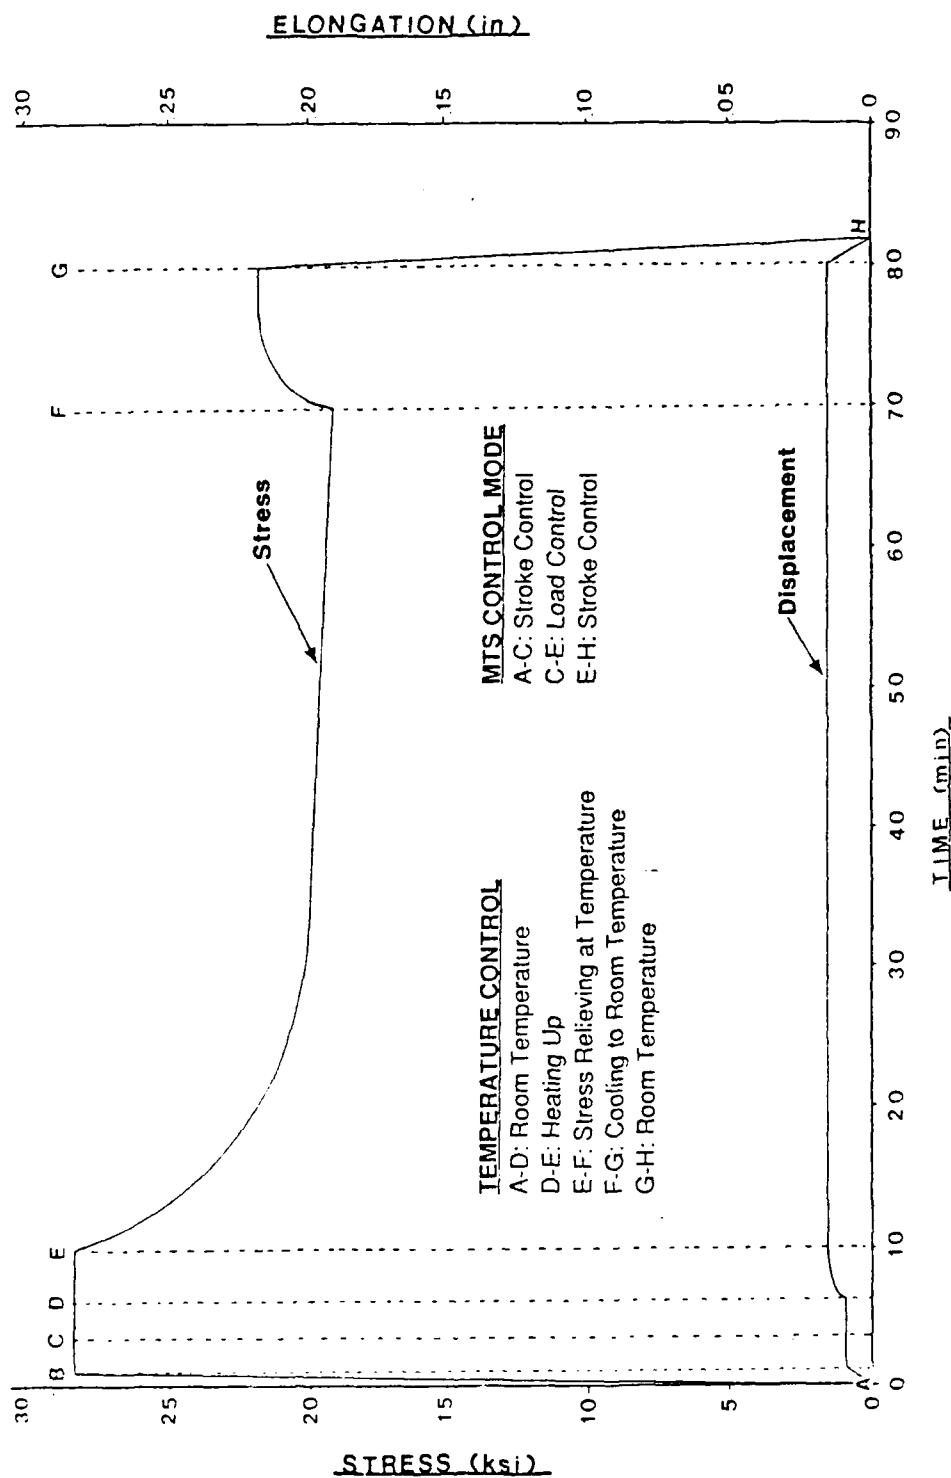
Figure 10. Stress Relaxation Schematic of the Testing

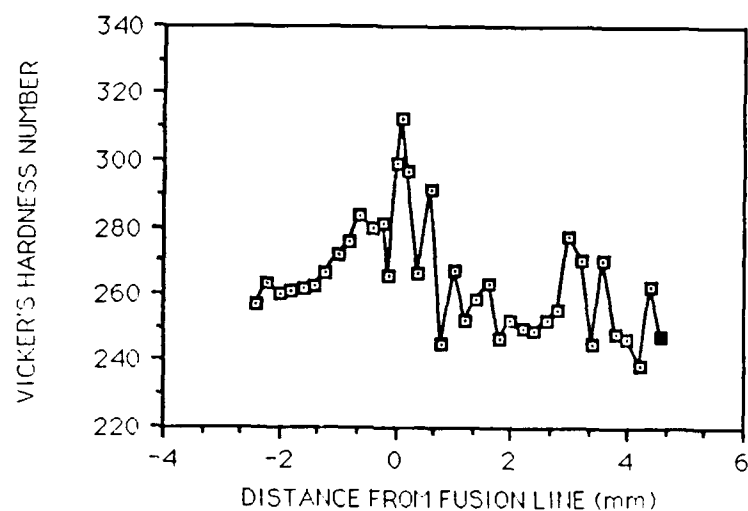
Figure 11. **Microhardness Traverse AA at the Center of the Weldment**

and 12. The profile of the two hardness measurements superimposed on one another is shown in Figure 13.

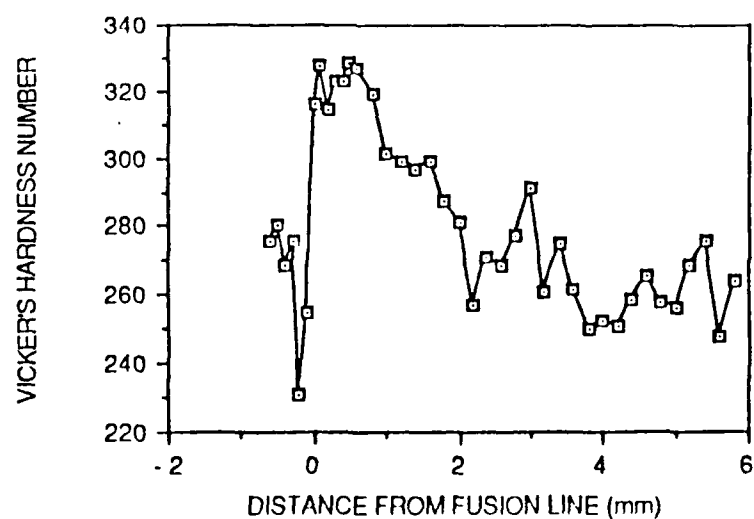
Figure 12. **Microhardness Traverse BB at the Last Weld Pass**

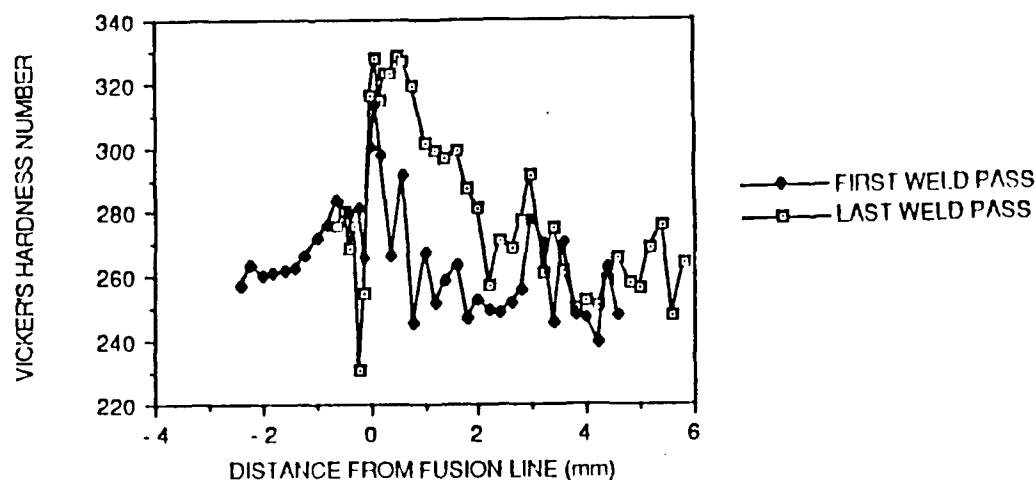
Figure 13. **Comparison of Microhardness Traverse AA and BB**

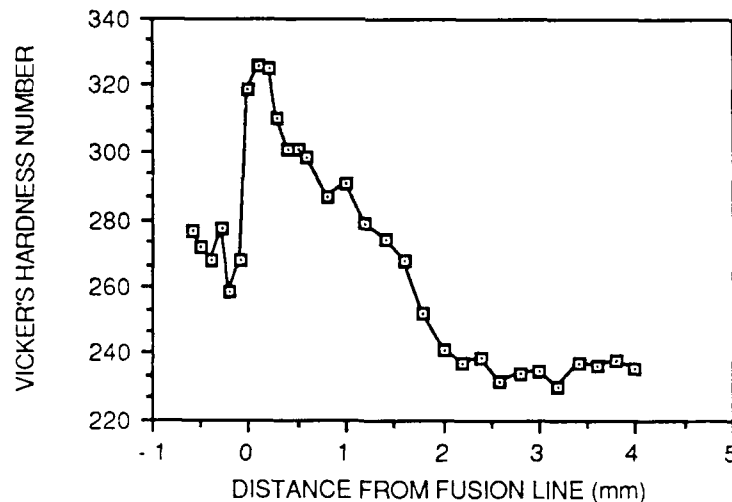
Figure 14. **Microhardness Traverse CC taken at the Center of the Weldment after Stress Relieving at 650° C for One Hour**

The hardness profile of CC (center of the 60° bevel after stress relief for one hour at 650° C), is illustrated in Figure 14. It has the same sharp discontinuity at the fusion line followed by a decreasing hardness across the HAZ. A maximum hardness of 328 VHN was obtained in the coarse HAZ and average value of 240 VHN was achieved in the base metal.

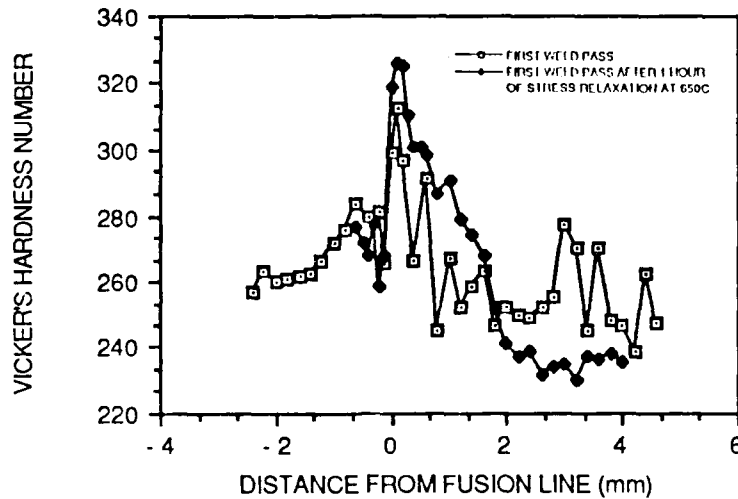
**Figure 15. Comparison of Microhardness Before (AA) and After (CC) Stress Relief Testing**

The hardness is higher in the coarse-grained HAZ and lower in the unaffected base metal for traverse CC.

The comparison of the hardness profiles of the center of the weldment before and after stress relief is shown in Figure 15.

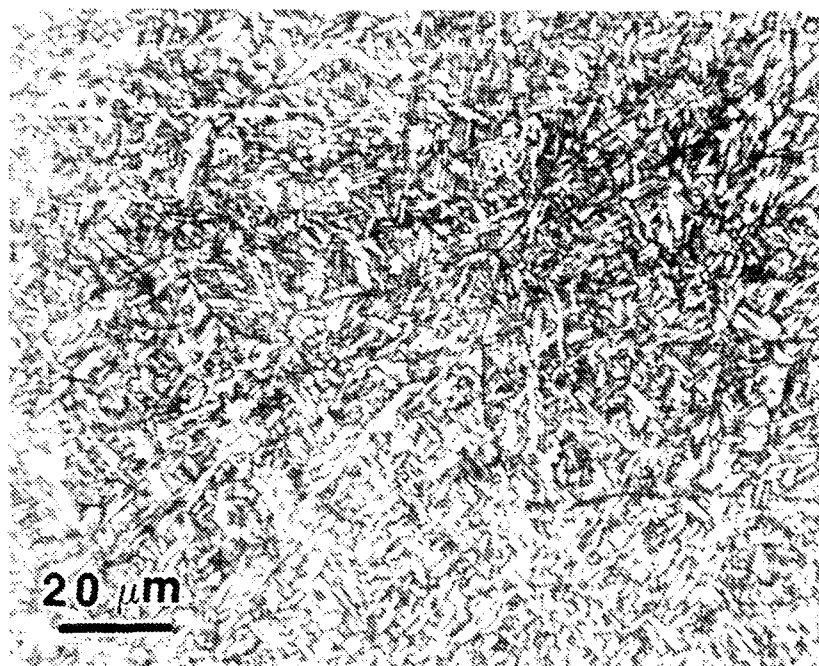
**Figure 16. Optical Micrograph of the Weld Metal in the As-Received Condition Depicting the Fine Acicular Ferrite**

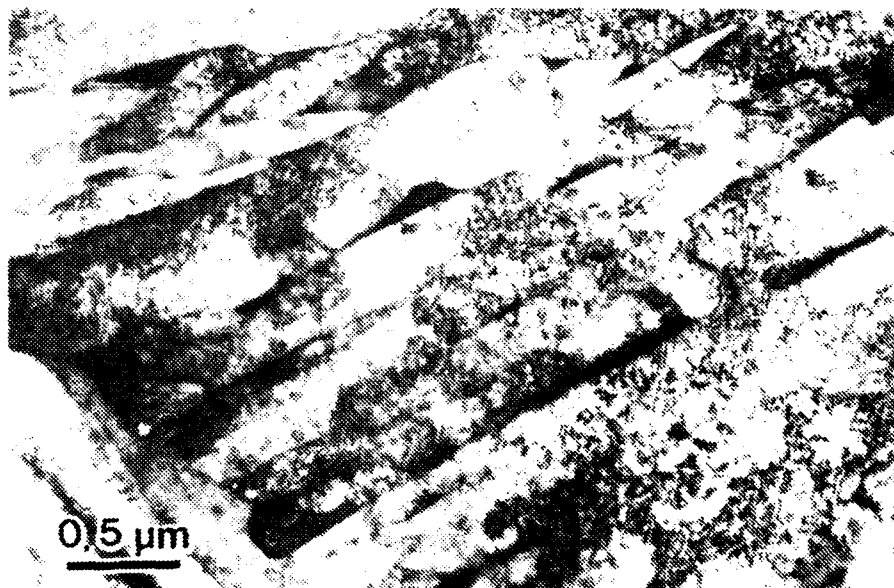
**Figure 17. TEM Micrograph Illustrating the Fine Acicular Morphology with a High Dislocation Density**

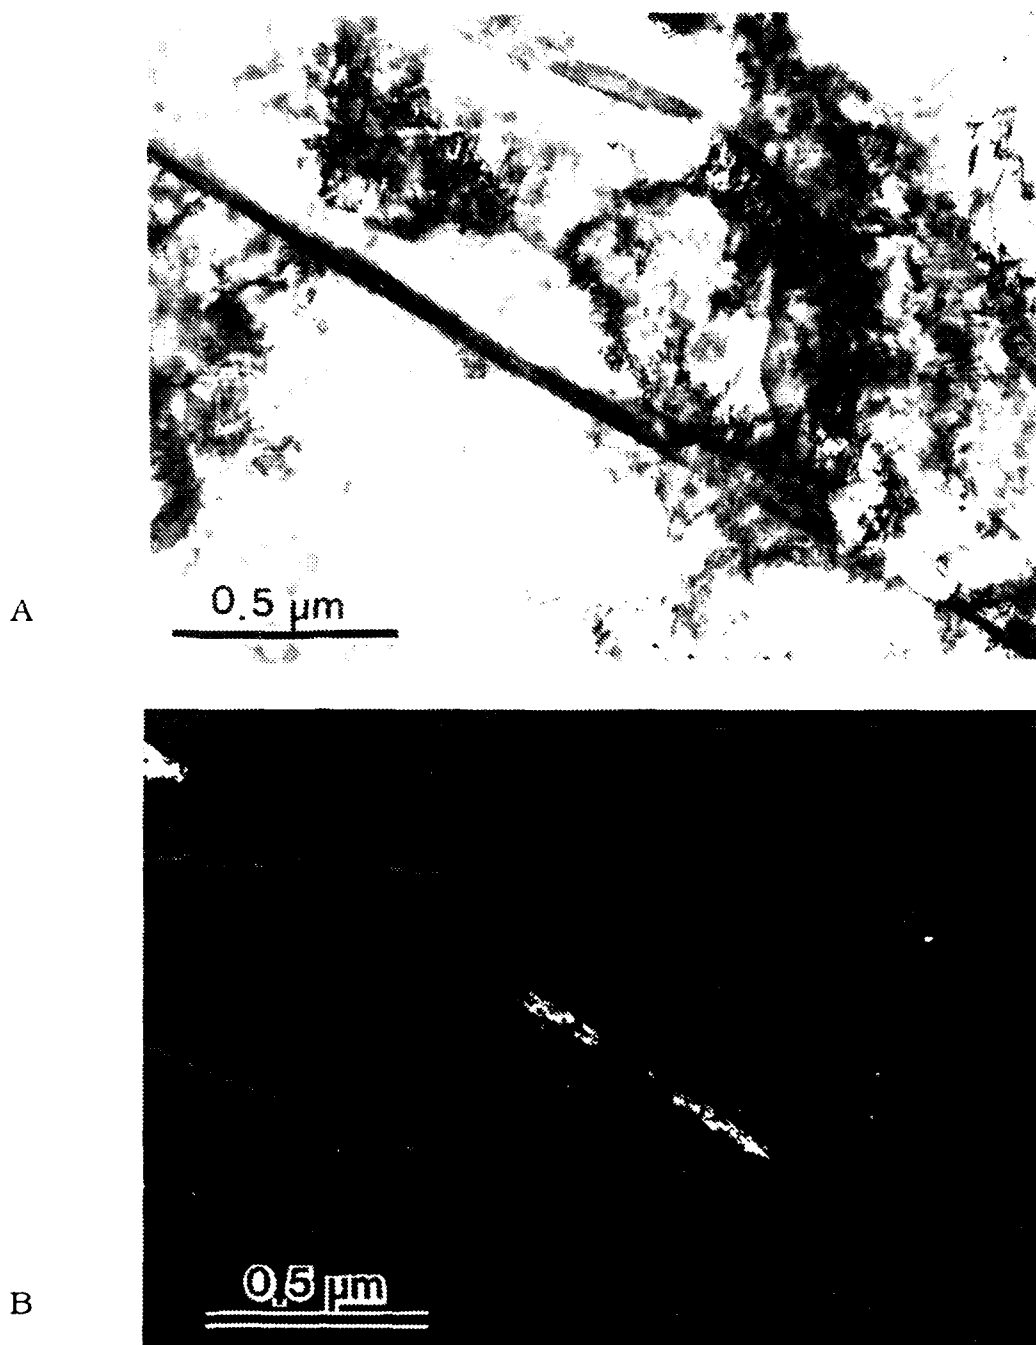
Figure 18. A **Bright Field TEM Micrograph of the Weld Metal Prior to Stress Relief Testing, Showing a Ferritic Structure and Twinning**  
B **Dark Field Illuminating the Twinning in the Same Region**

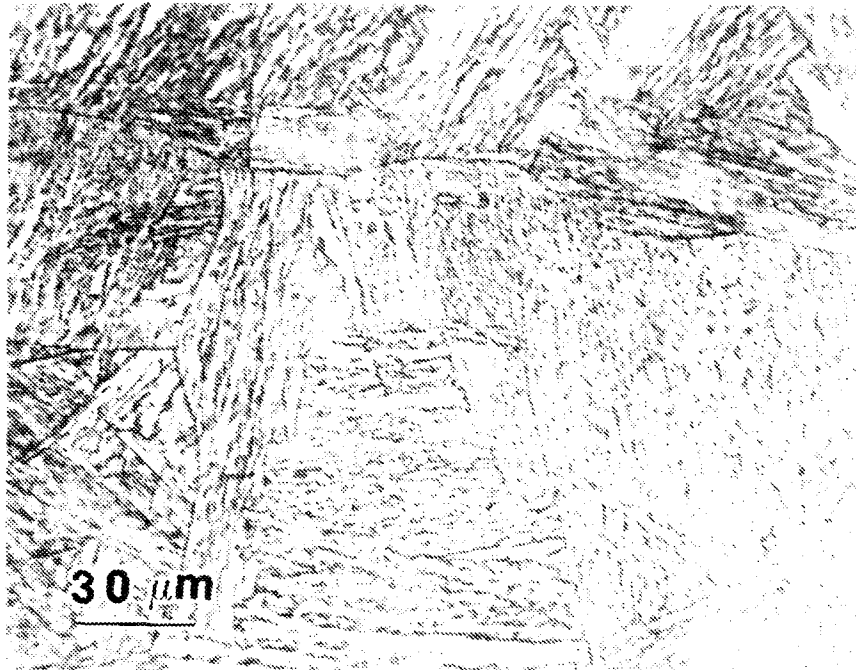
**Figure 19. Coarse-Grained HAZ Illustrating the Well-Defined Prior Austenite Grain Boundaries**

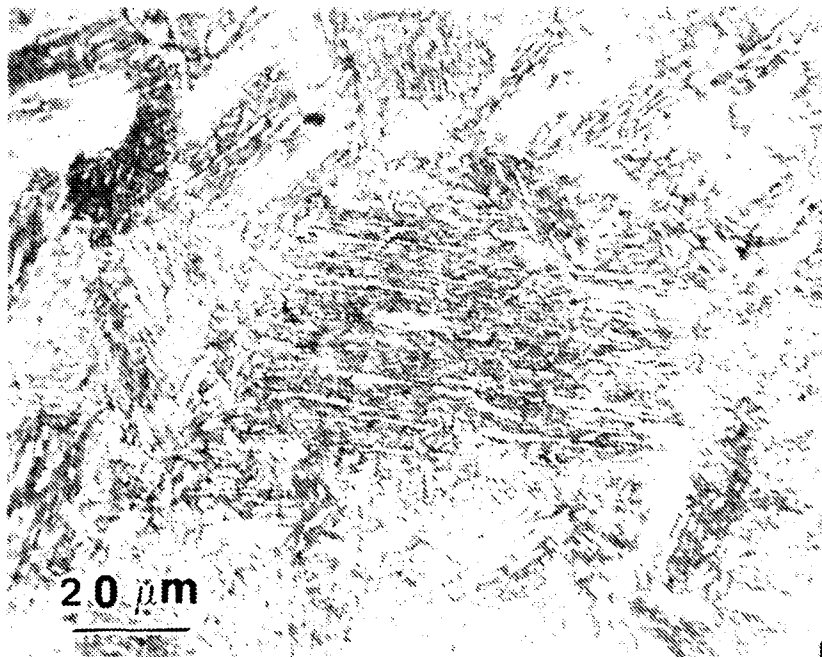
**Figure 20. Coarse-Grained HAZ Illustrating the Poorly Defined Prior Austenite Grain Boundaries**

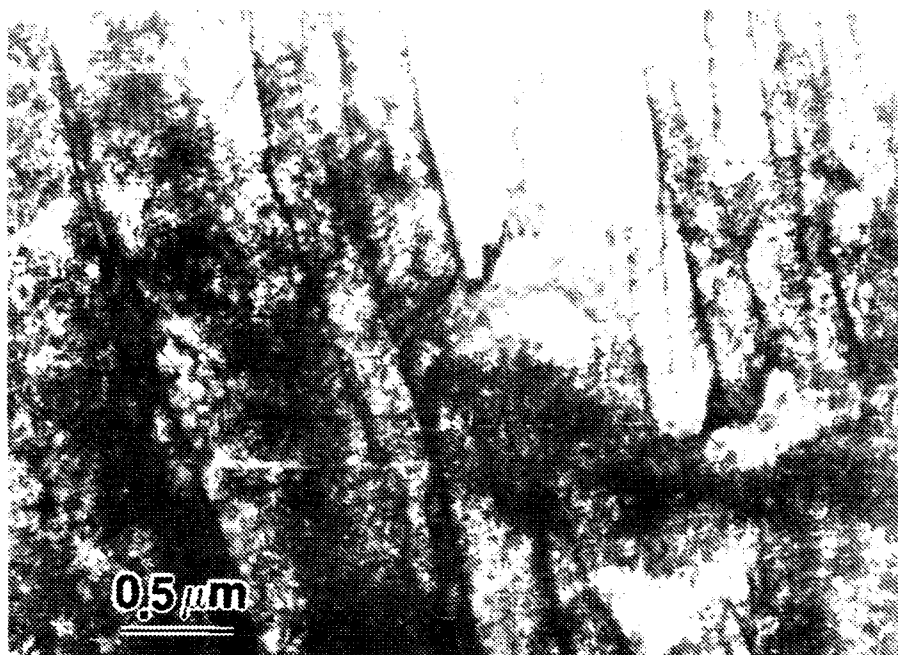
Figure 21. A **Bright Field Micrograph Illustrating the Lath Morphology and High Dislocation Density**  
B **Dark Field Micrograph of the Same Area Illuminating the Retained Austenite Between the Laths**

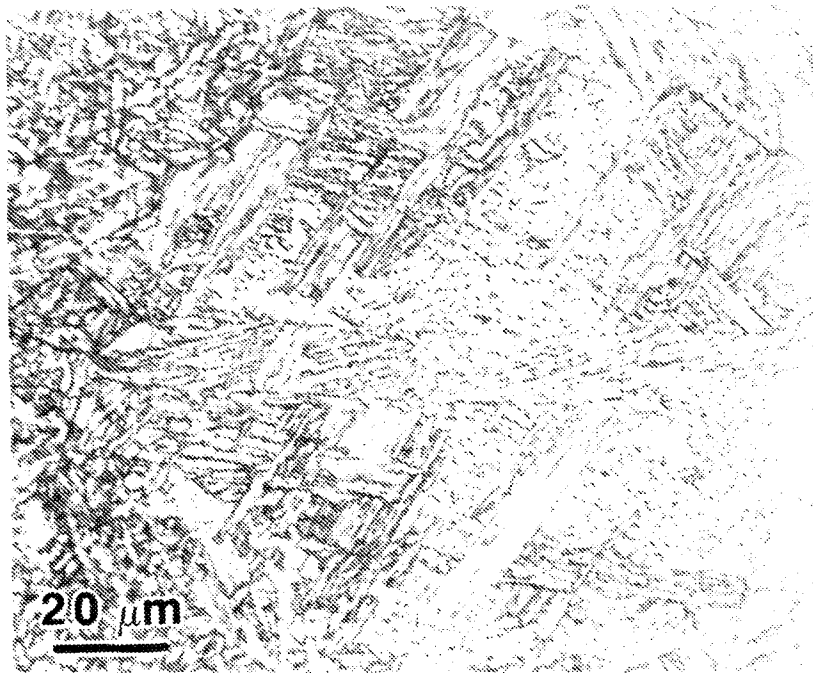
Figure 23. **Optical Micrograph of the Fusion Line at the Center of the 60° Bevel**

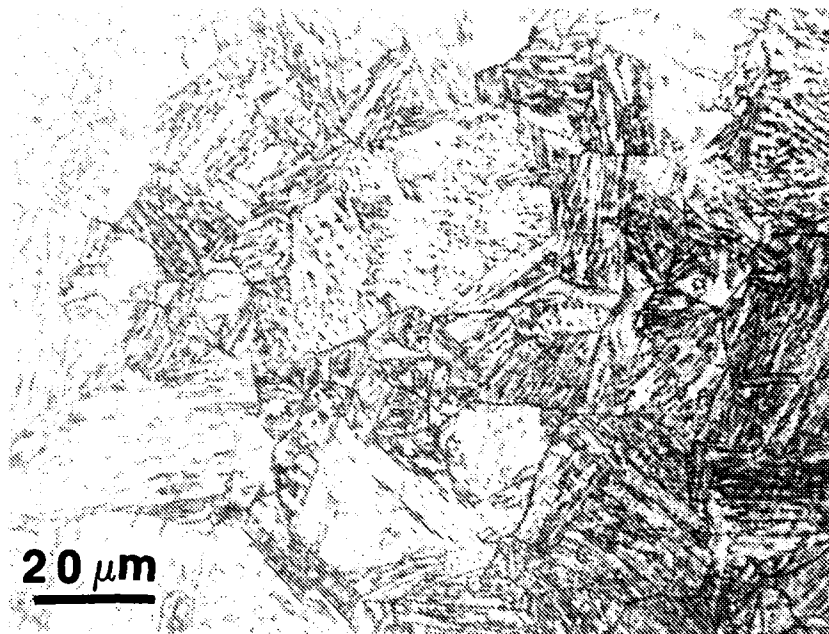
Figure 24. **Optical Micrograph Taken in the Middle of the HAZ**

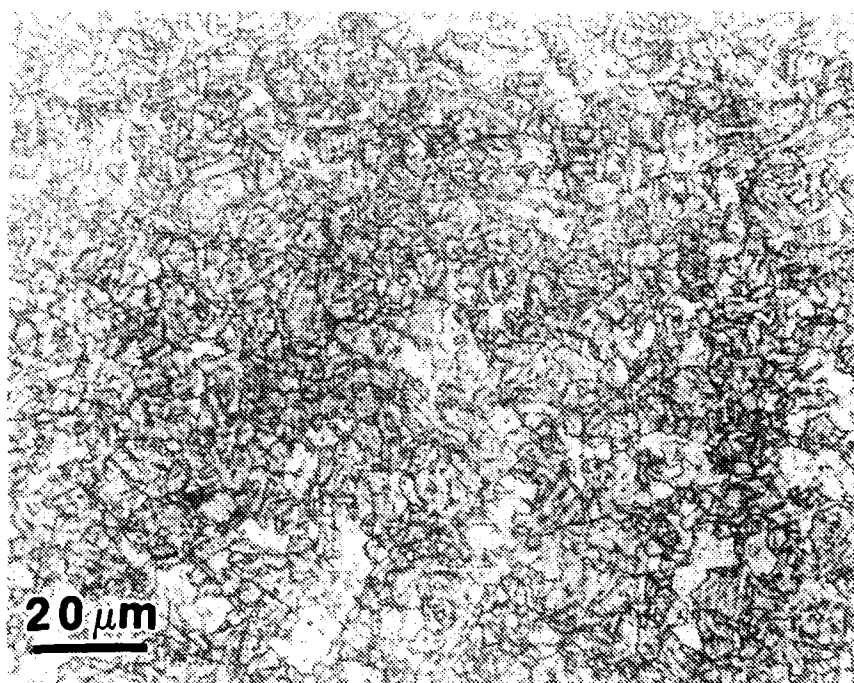
Figure 25. **Optical Micrograph of the Fine-Grained HAZ Illustrating the Decrease in Grain Size from Figure 24**

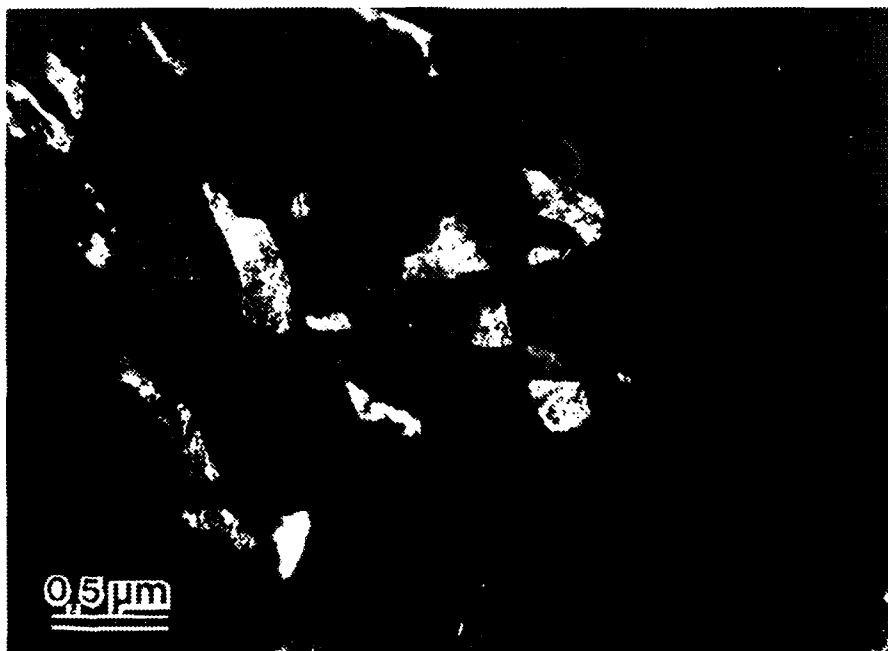
Figure 26. A **Bright Field Micrograph of a Grain in the Fine-Grained HAZ**  
B **Dark Field Micrograph of the Same Area Illuminating the Islands of Retained Austenite Inside the Grain**

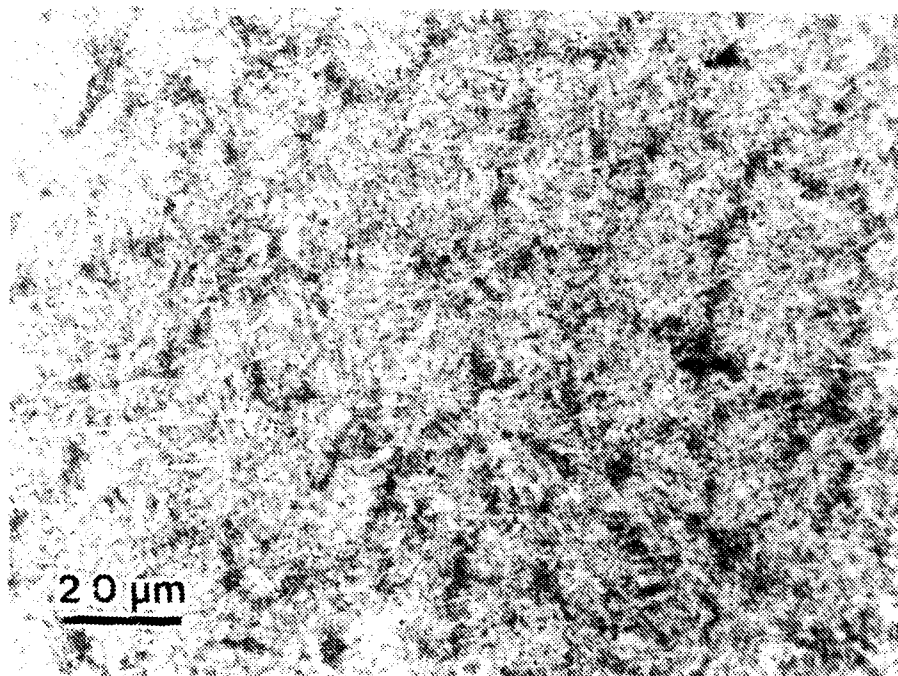
**Figure 30. Optical Micrograph of the Weld Metal After Stress Relieving at 650° C for One Hour**

The weld metal was essentially acicular ferrite (Figure 30). TEM analysis showed interlocking laths and some inclusions which are characteristic of an acicular ferrite microstructure.

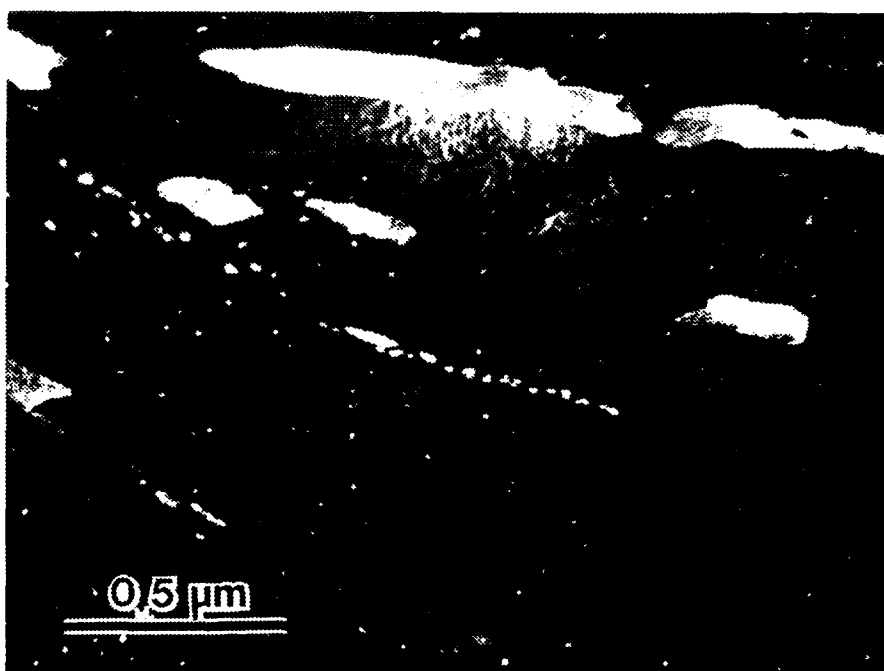
Figure 32. **TEM Micrograph Indicating Retained Austenite**

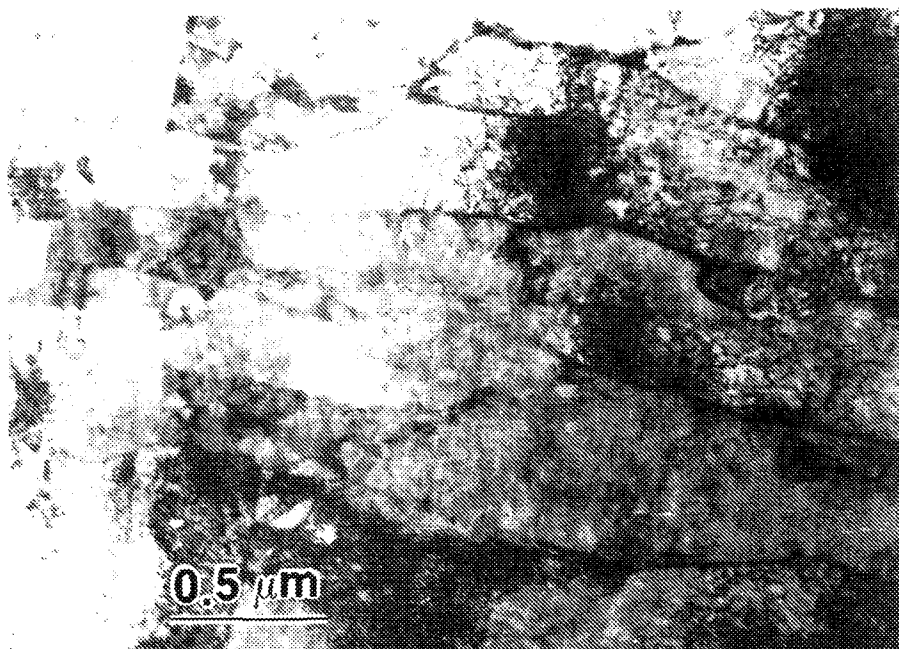
Figure 33. A **Bright Field Micrograph Showing the Lath Morphology**  
B **Dark Field Micrograph Illuminating the Copper Pre-  
cipitation on the Lath Boundary**

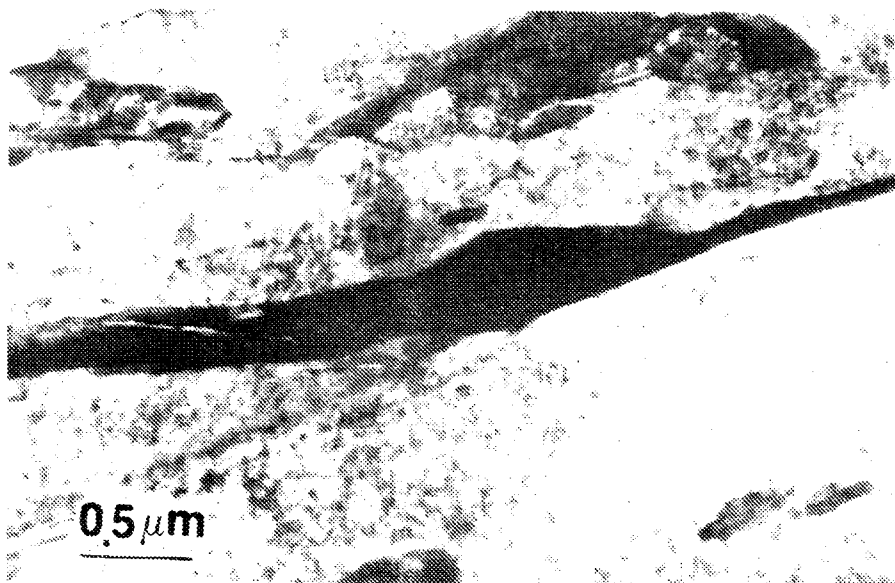
**Figure 34. TEM Micrograph of the Fusion Line Indicating a Lath Morphology and Relatively Large Second-Phase Particles (Dark Region)**

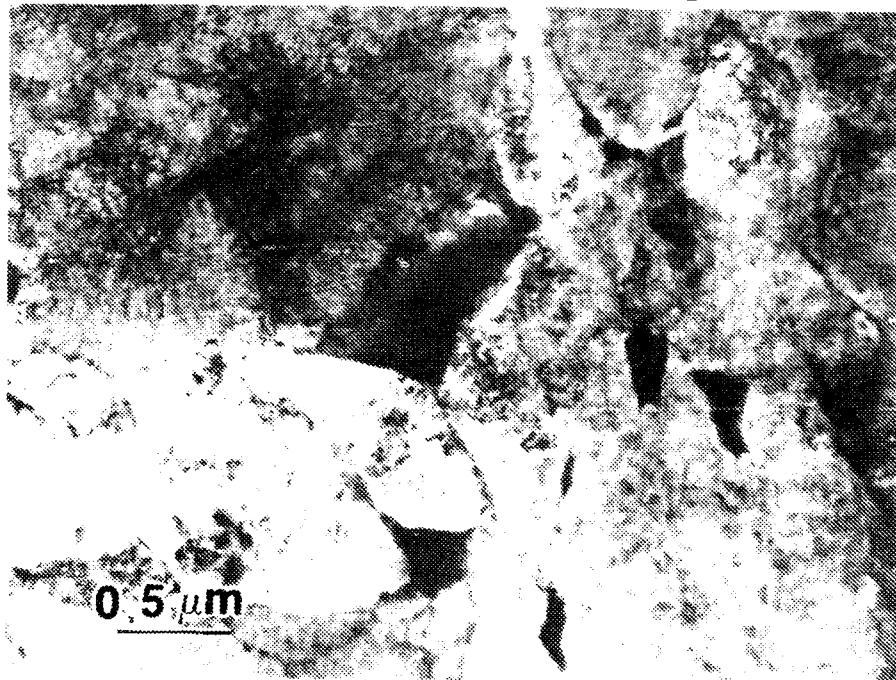
**Figure 35. TEM Micrograph of the Fusion Line Indicating a Disrupted Morphology with Second-Phase Particles on the Grain Boundary and Within the Grains**
